Roof Condition Report

Metchosin Fire Hall

30 January 2013

Roof Condition – Metchosin Fire Hall

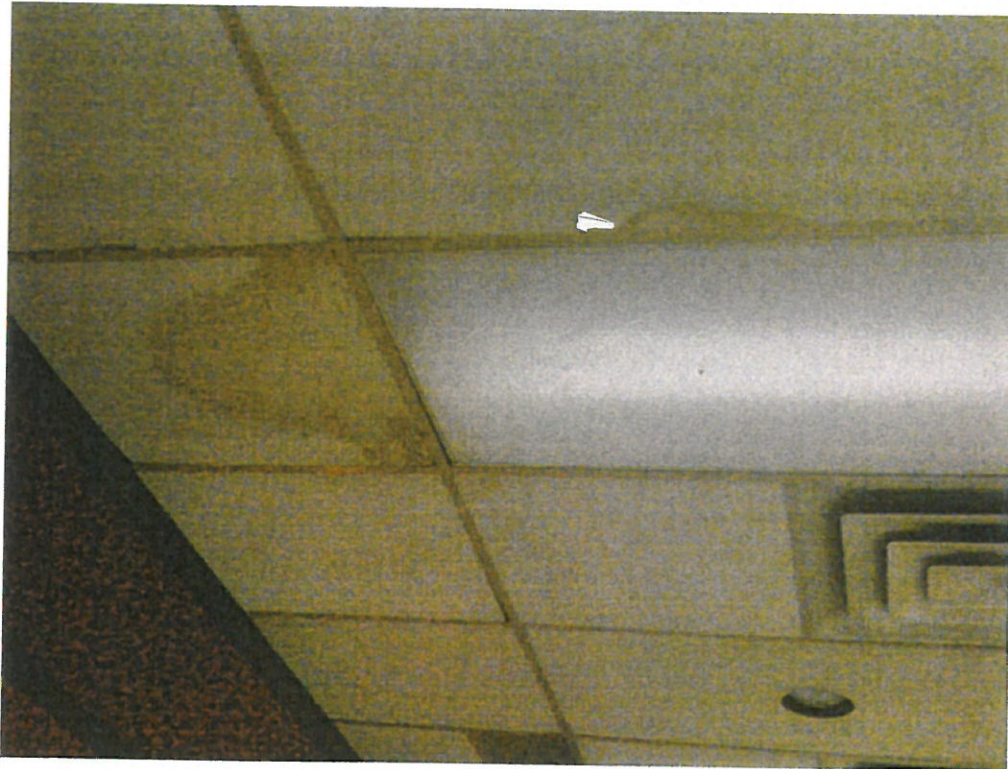
Above is a picture in the lounge by the back entrance, as our facility is not only occupied with volunteer firefighters, the scouts, the seniors, SAR and EOC personal and other local municipal and Westshore organizations. Many events such as Halloween, School Expo, Auto Ex Competitions and many forms of training, the public perception portrays a negative effect on our hall and community.

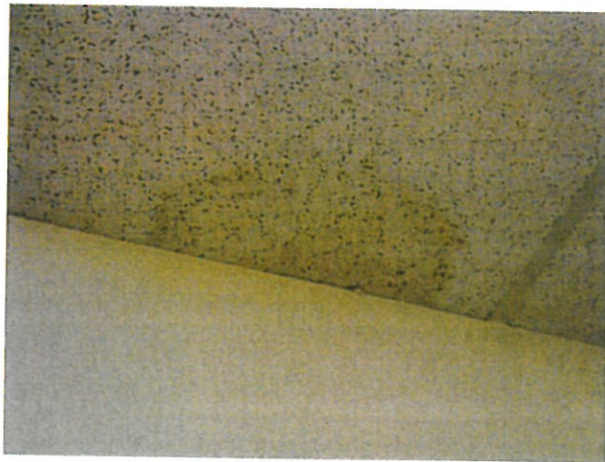
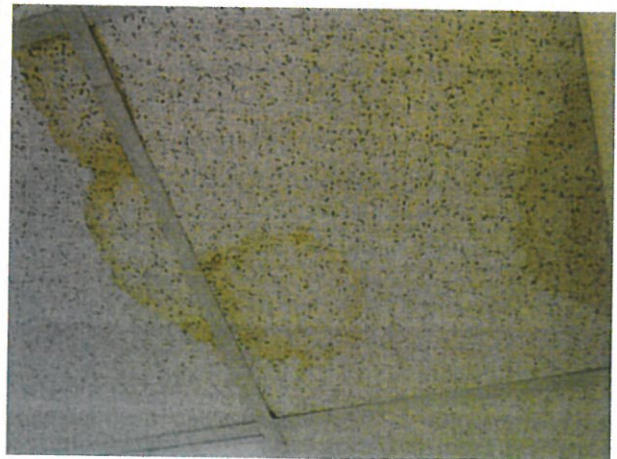
Interior hallway towards offices.

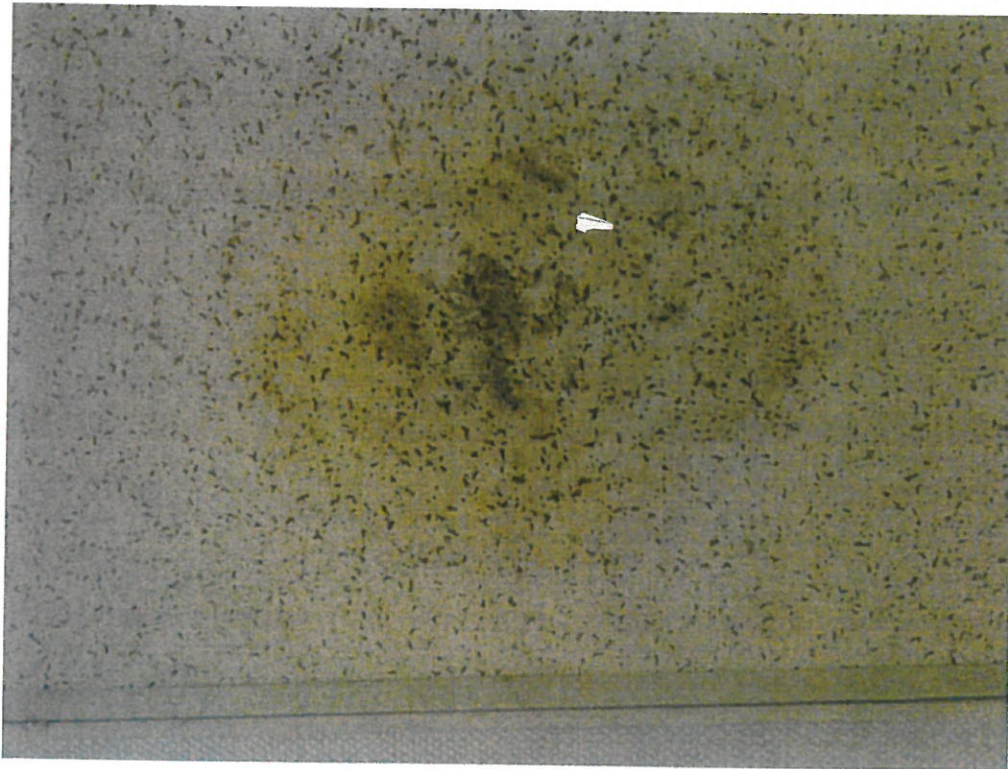
Roof interior inside the Fire Support personnel's office.

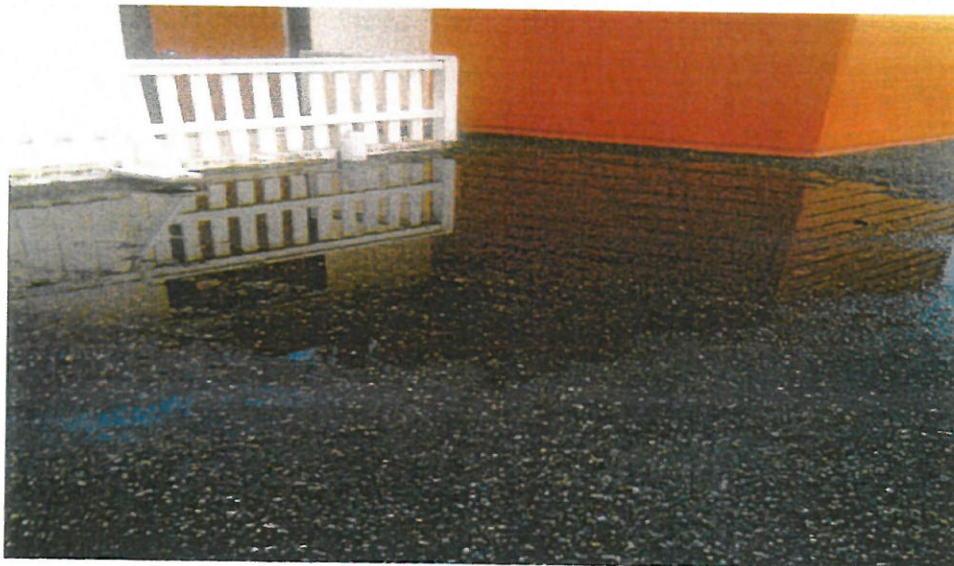
The pooling you see here is called "pondling", location here is outside the upper training room classroom. One of the issues here is the added weight of water on our structure, also improper location of drains.

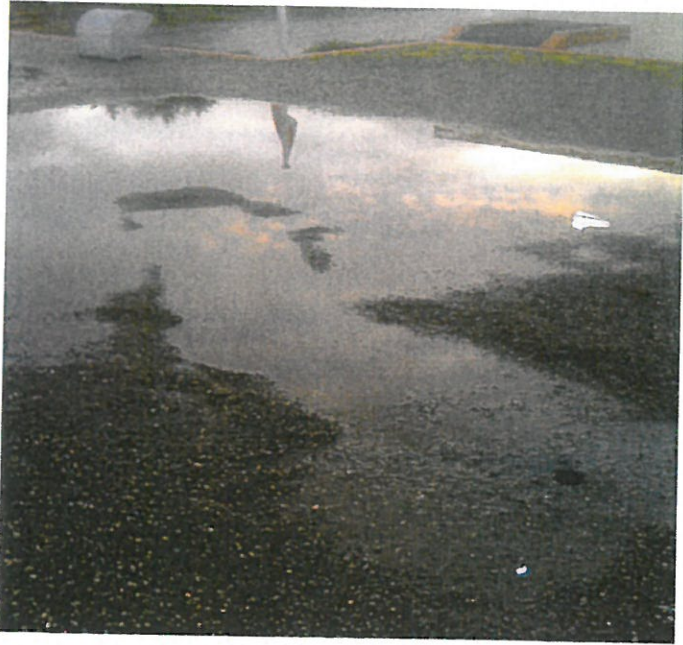
From the last photo, turning 90 degrees, facing flag pole, more pondling, added weight and improper drainage.

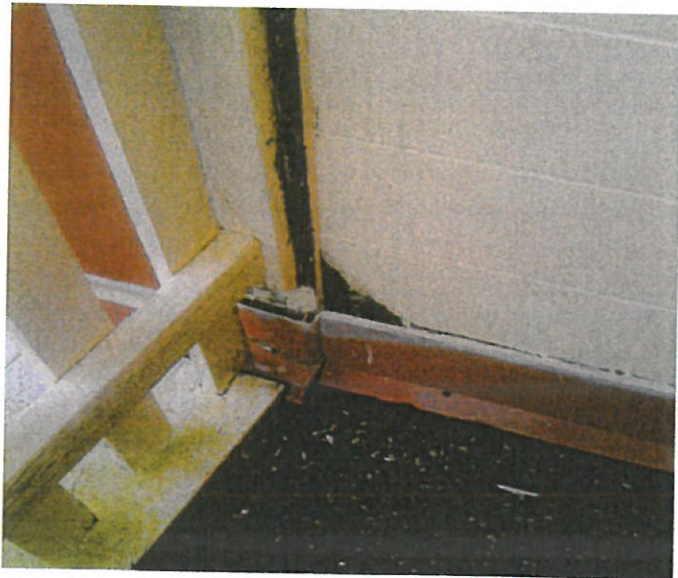
Location upper training room door, part of cinderblock is missing, and flashing not adhere to building.

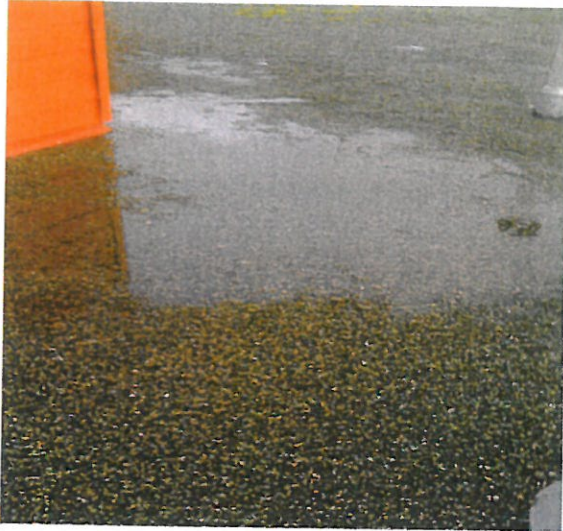
Roof adjoining old hose tower, more ponding, weight, ponding at seem of structure.

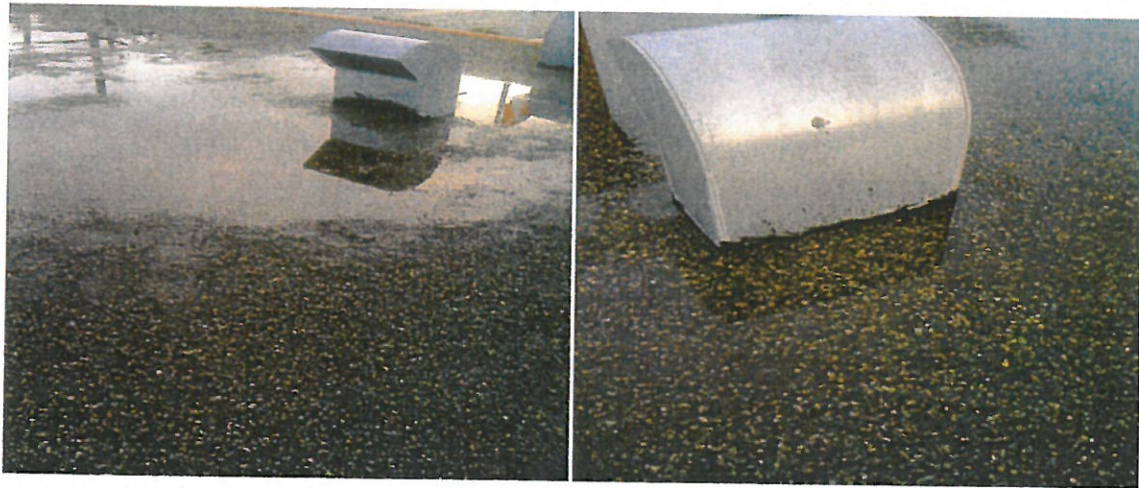
More ponding, the issue here the ponding is around HVAC outlets, which has possible egress to interior.

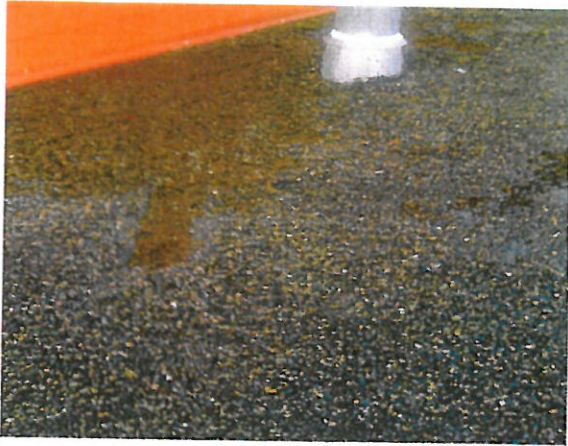
Pondling at old hose tower structure front side at roof.

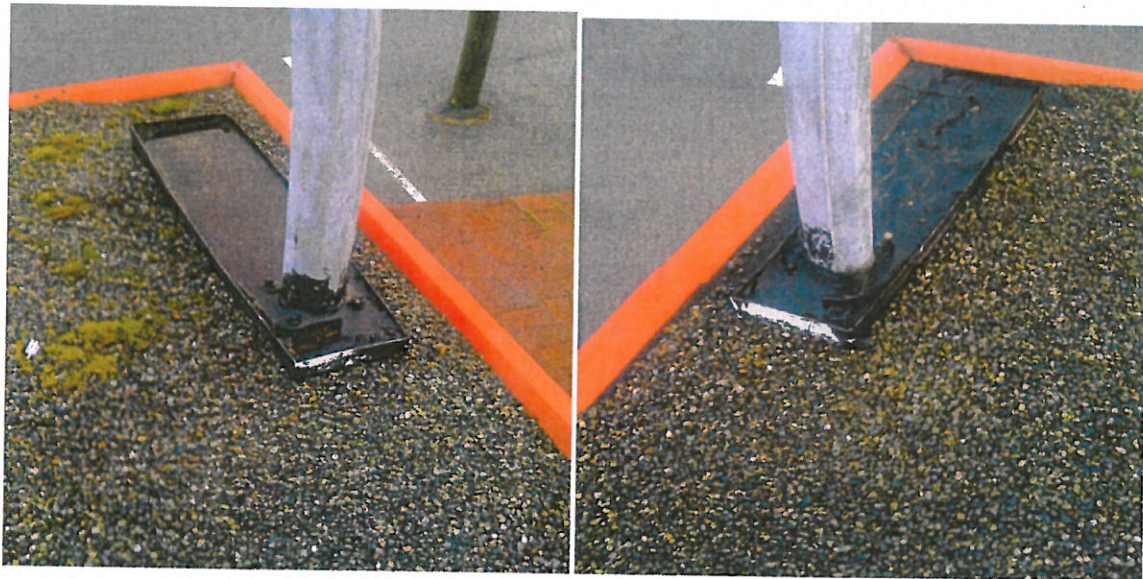
Light standards mounted front of hall on roof, improper installion, pan had been inadequately filled with tar, thus pans are filled with water. Should be filled and with concave topping to allow water to run off.

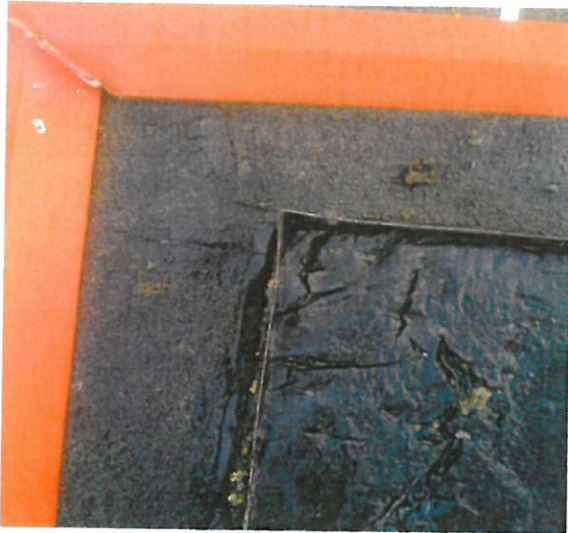
Exposed tar, no gravel to protect, cracks which make good egress of water to interior.

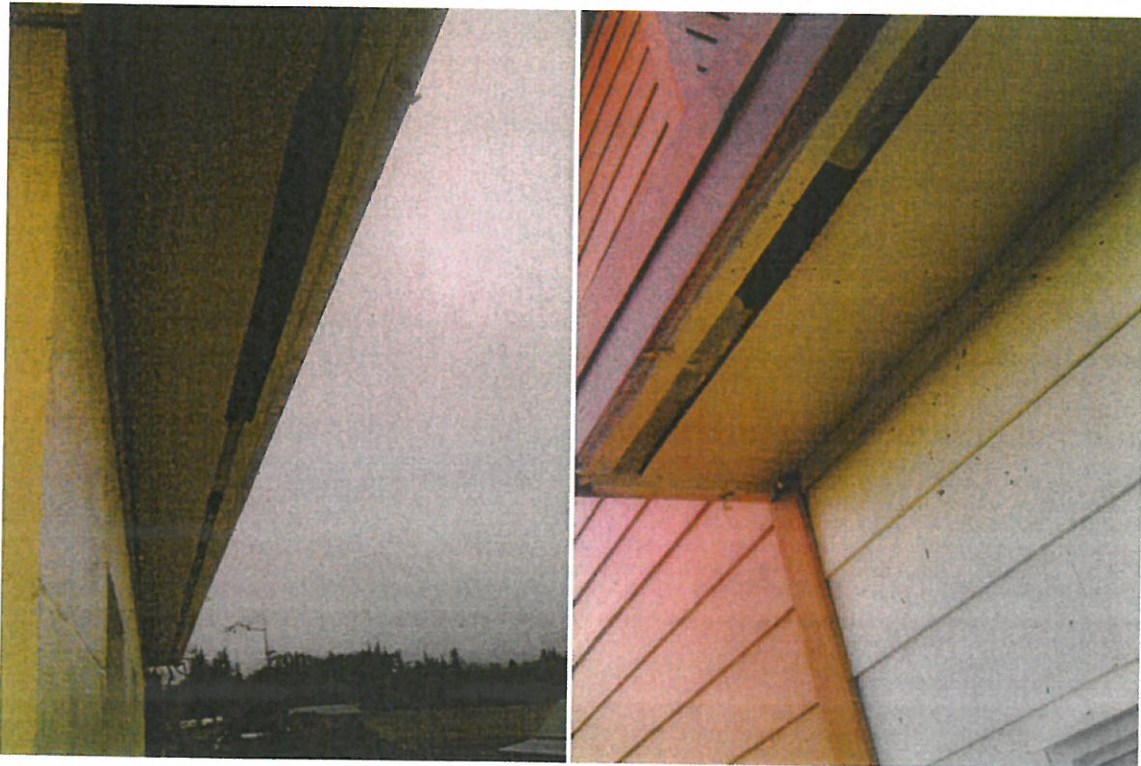
Roof venting, there are many fixes here with different types of methods, due to age, birds are making egress easily for nesting, etc..

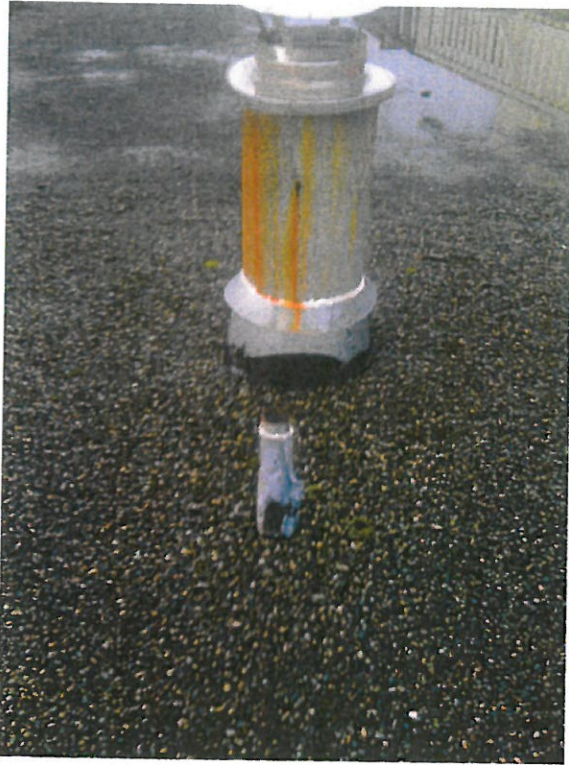
Some roof vents are need of repair or replacement.
