Hazardous Materials Survey Report
4440 Valley Rd.
Victoria, BC

Project - 22645

Firehall Located at 4440 Valley Rd., Victoria, BC

April 22, 2022

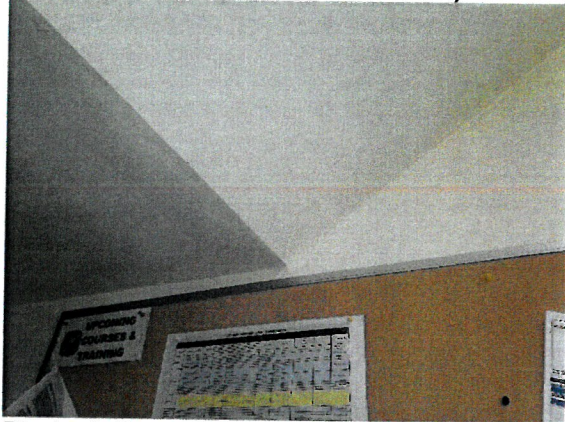
Photo 1: Drywall Compound – Main Floor Stairs to Truck Bay (ND – none detected)

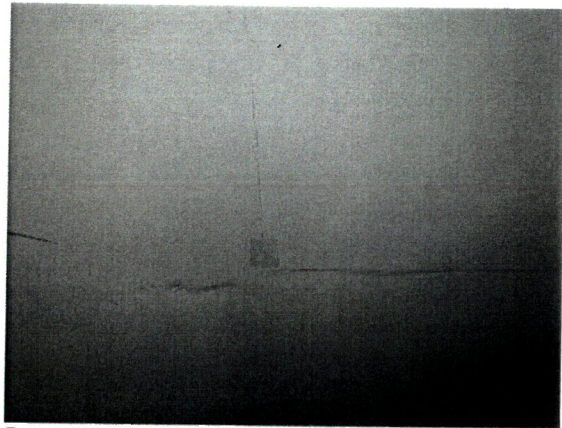
Photo 2: Drywall Compound – Gym (ND)

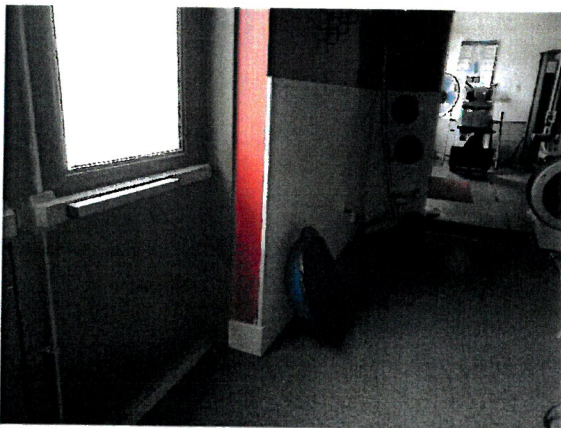
Photo 3: Drywall Compound – Sauna Room (ND)

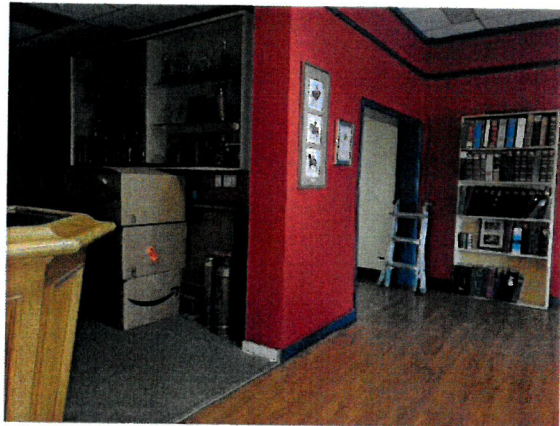
Photo 4: Drywall Compound – Reception Hallway (ND)

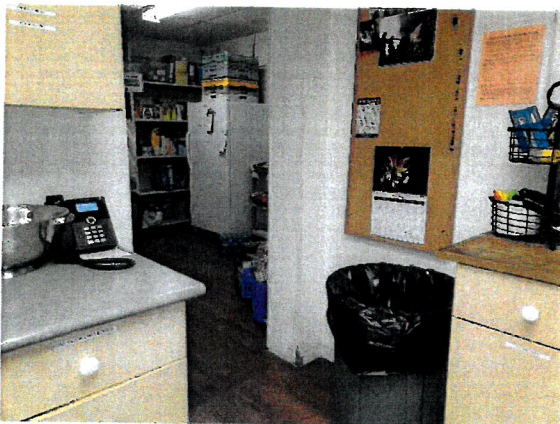
Photo 5: Drywall Compound – Kitchen (ND)

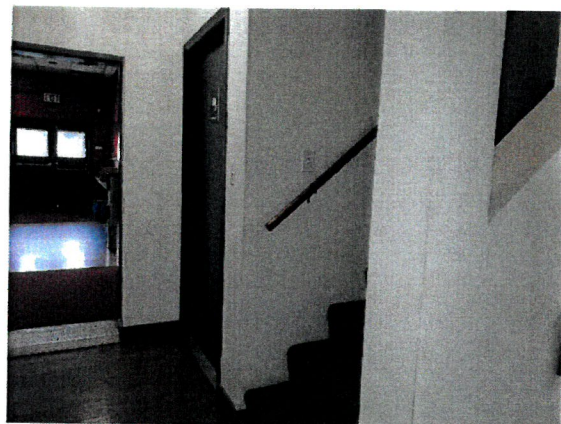
Photo 6: Drywall Compound – Stairs To 2nd (ND)

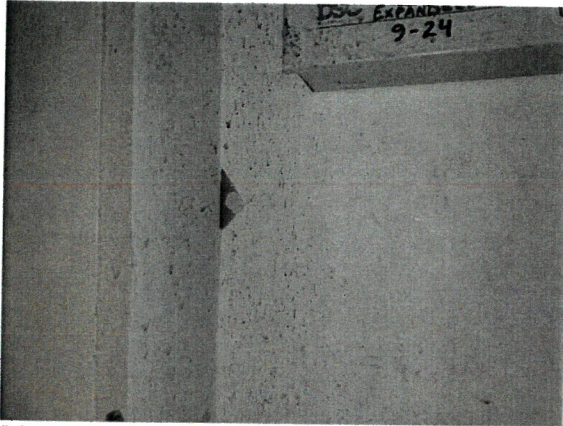
Photo 7: Drywall Compound – Cleaning Closet (ND)

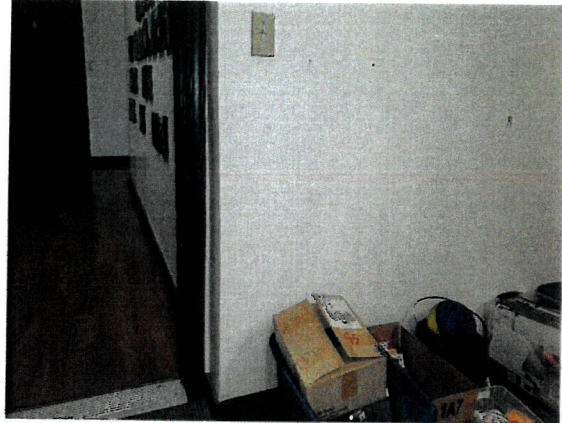
Photo 8: Drywall Compound – Training Room (ND)

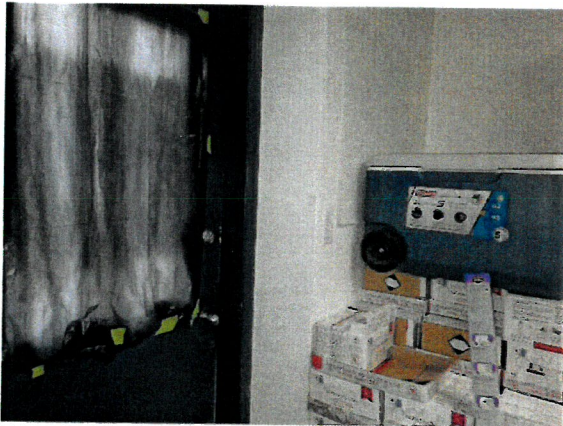
Photo 9: Drywall Compound – Storage/Training Room (ND)

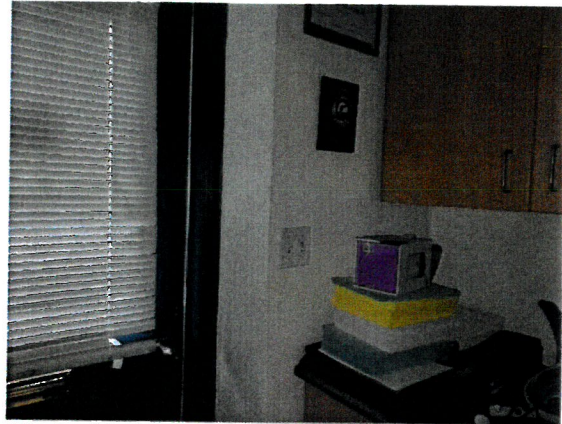
Photo 10: Drywall Compound – Chief Office (ND)

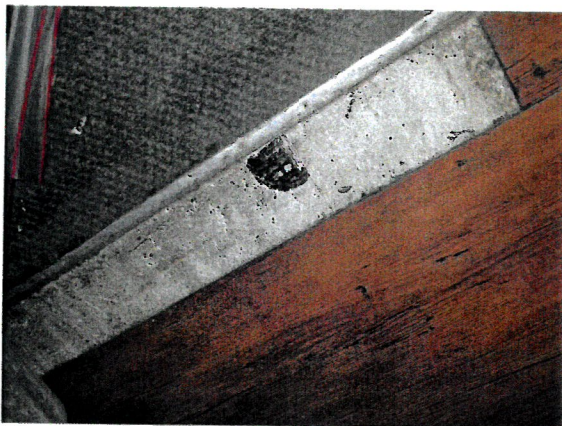
Photo 11: Vinyl Floor Tile – Banquet Hall Below Laminate (ND)

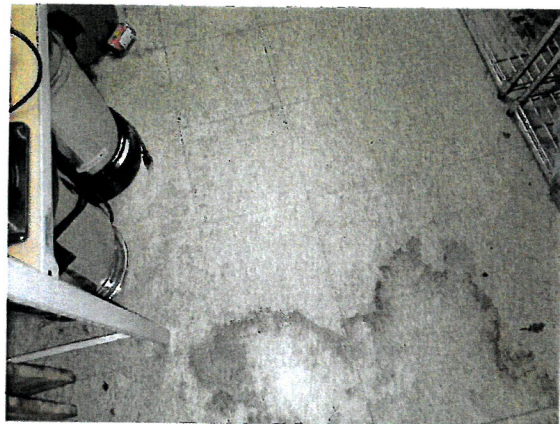
Photo 12: Vinyl Floor Tile – Kitchen Storage (ND)

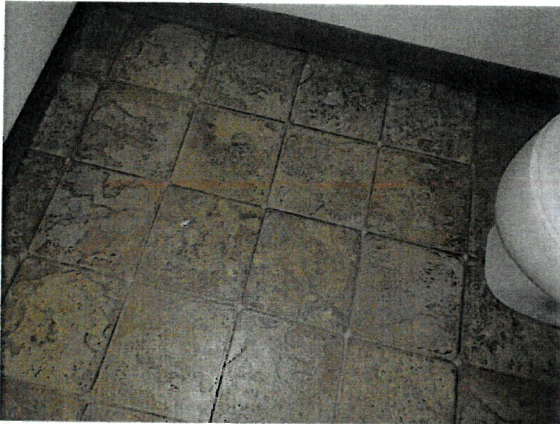
Photo 13: Sheet Vinyl Flooring – Washroom (ND)

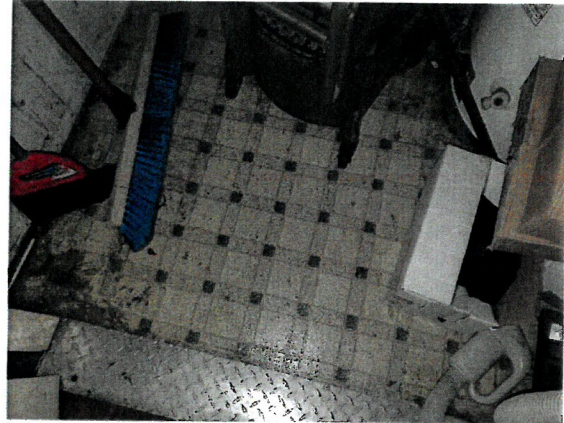
Photo 14: Sheet Vinyl Flooring – Cleaning Closet (ND)

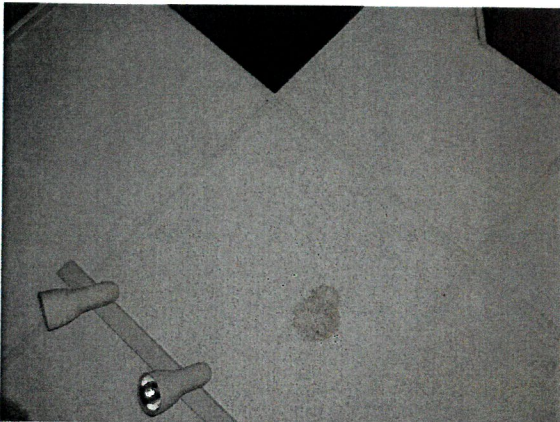
Photo 15: Ceiling Tile – Throughout Main Floor (ND)

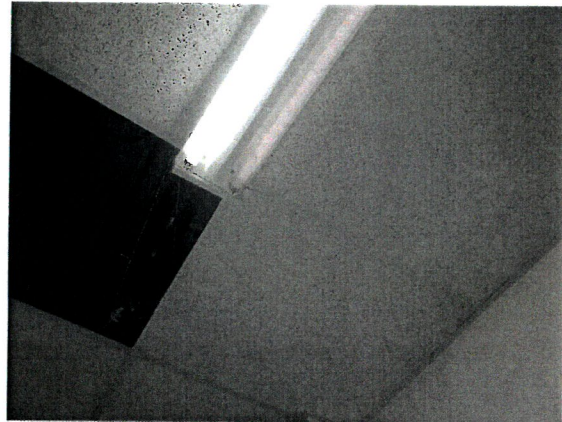
Photo 16: Ceiling Tile – Throughout Main Floor (ND)

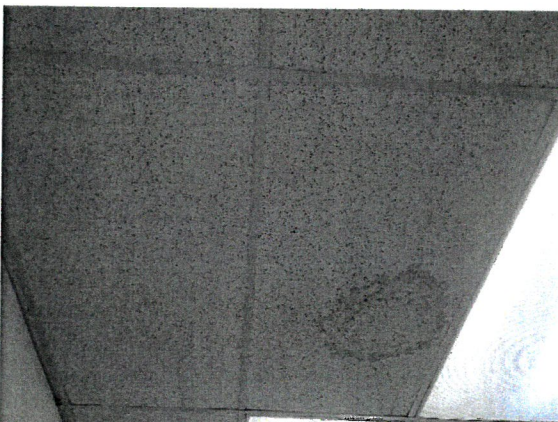
Photo 17: Ceiling Tile – Throughout Main Floor (ND)

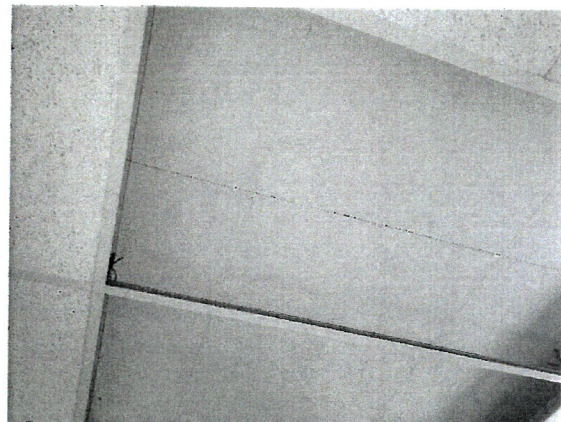
Photo 18: OSB Ceiling Tile – 2nd Floor Above Ceiling Tile (ND)

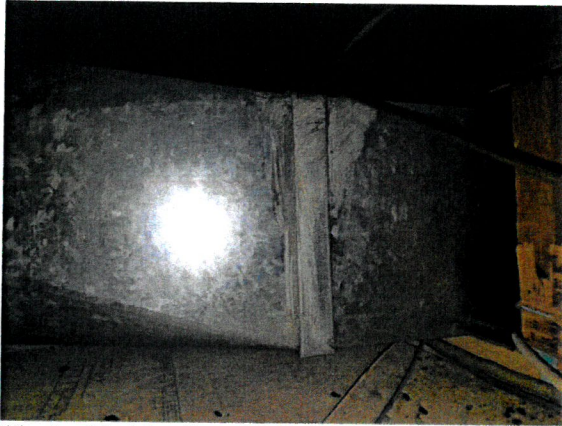
Photo 19: Mastic – HVAC
(ND)

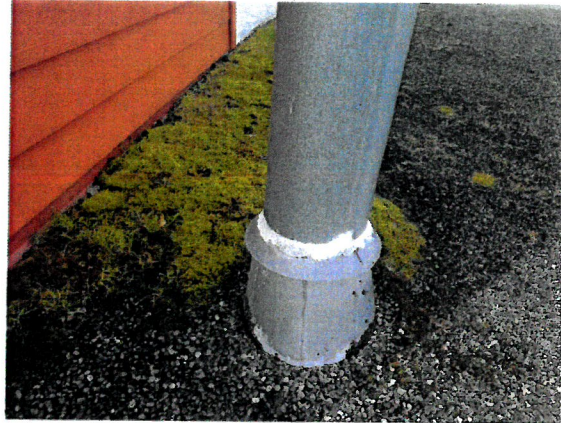
Photo 20: Caulking – Roof on Vent
(ND)

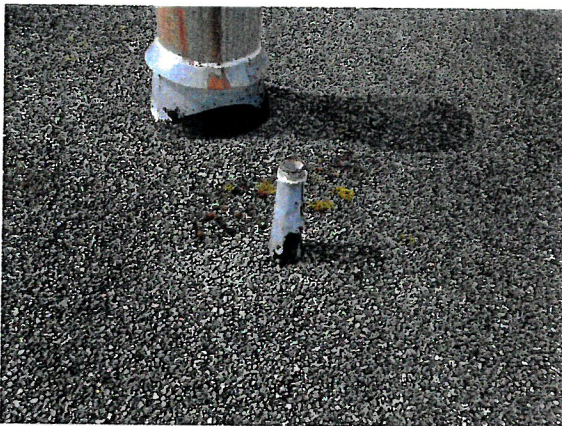
Photo 21: Tar – Roof on Vent
(ND)

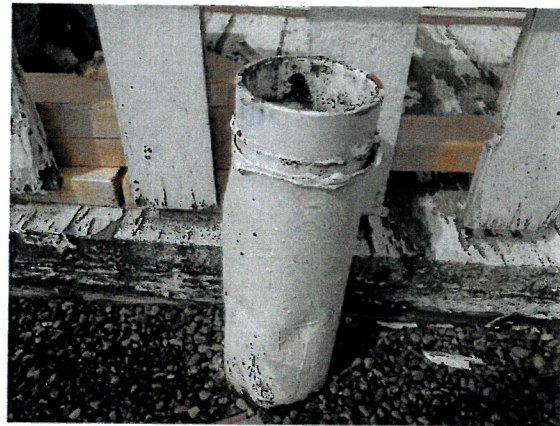
Photo 22: Caulking – Roof on Vent
(ND)

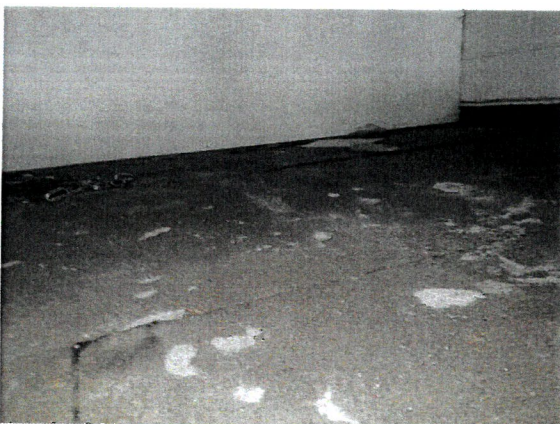
Photo 23: Torchon Membrane Roofing –
Gym Awning (ND)

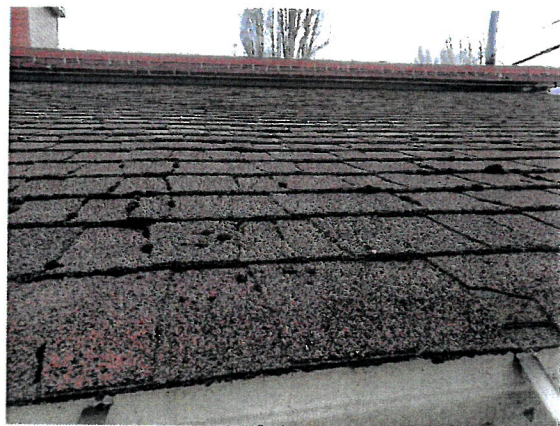
Photo 24: Composite Shingle – Gym
Addition (ND)

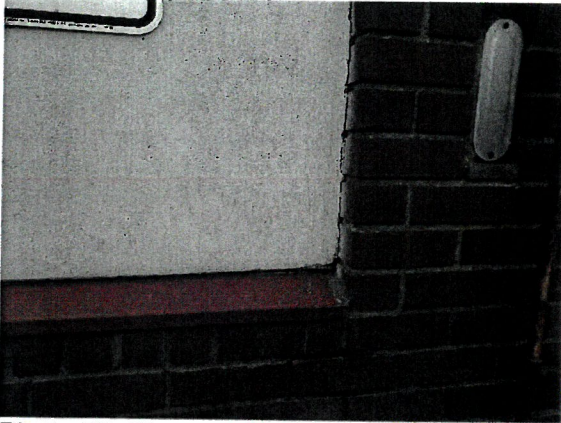
Photo 25: Stucco – Exterior Front
(ND)

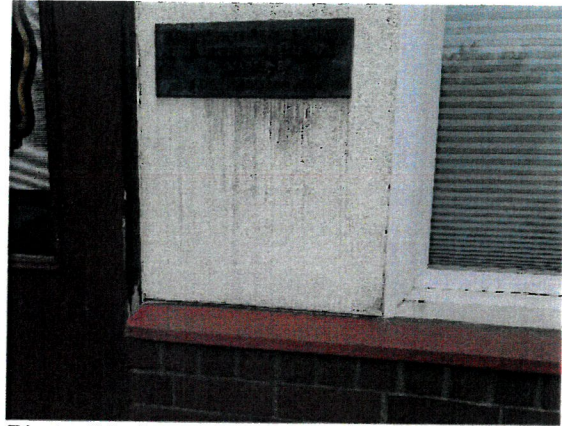
Photo 26: Stucco – Exterior Front
(ND)

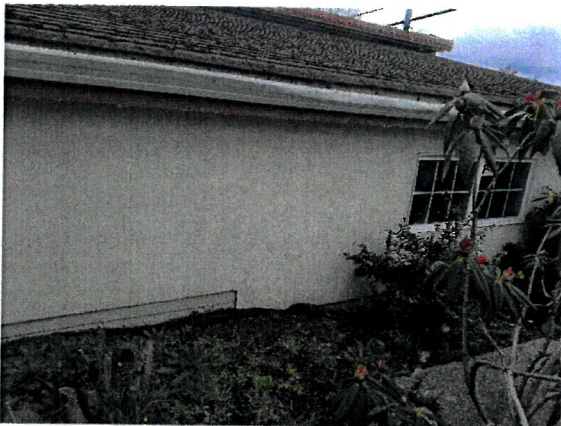
Photo 27: Stucco – Exterior Side
(ND)

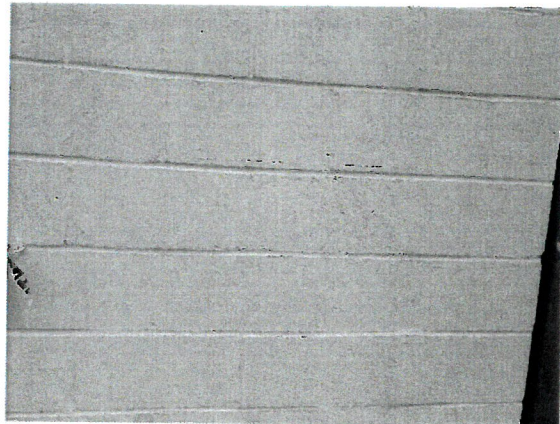
Photo 28: Mortar – Block Mortar
(ND)

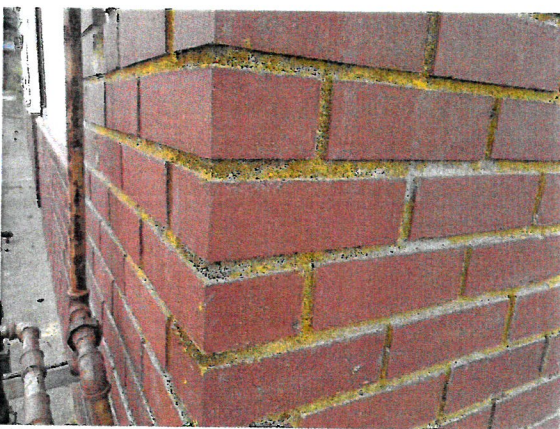
Photo 29: Mortar – Exterior Front
(ND)

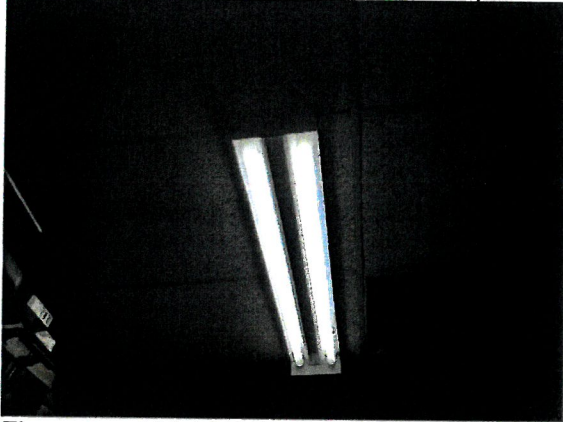
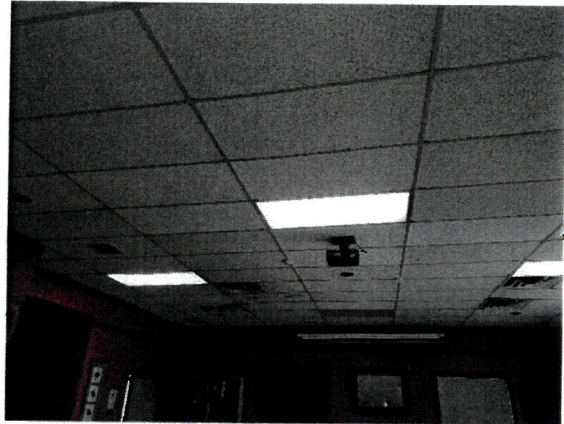
Fluorescent light ballasts were observed (see photos). These fixtures may contain PCB ballasts.

Fluorescent tube lights were observed (see photos). Fluorescent bulbs are known to contain mercury.

Fluorescent Light Ballast; Fluorescent Tube Lights (PCB; Mercury)

Prior to disposal, ballasts should be stored in a safe and secure location for inspection to determine the presence or absence of PCB’s. Any PCB containing ballasts determined to be present must be stored in an approved storage facility or disposed of by a certified company that will accept ownership of the ballasts.

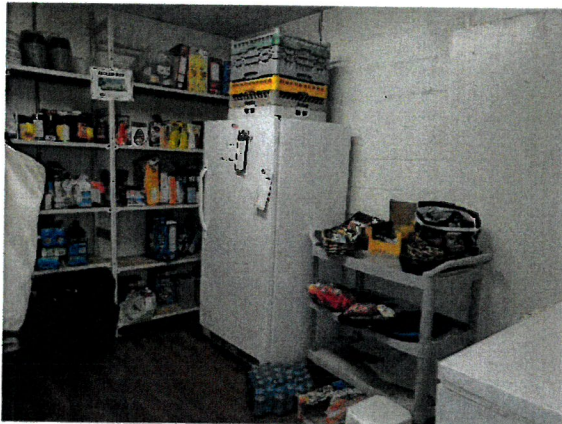
A refrigerator and freezer were observed (see photos) – refrigerators made before 2005 may contain ODSs. ODSs such as chlorinated fluorocarbons (CFCs) were used in chemical fire suppression systems and refrigeration and air conditioning units. In the case of demolition, these ODSs will require proper recovery and disposal by a licenced contractor, in accordance with the BC Ozone-Depleting Substances Regulation.

Refrigerator (ODS)

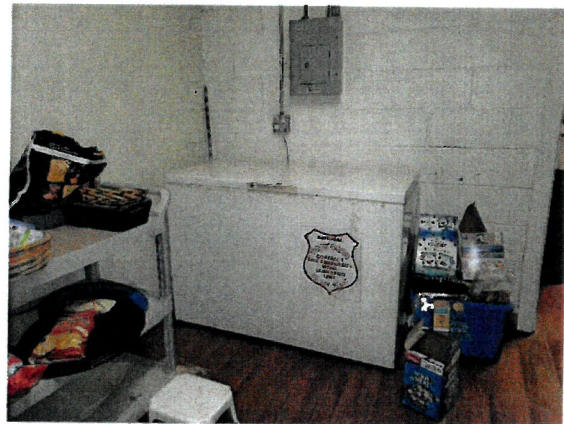
Freezer (ODS)

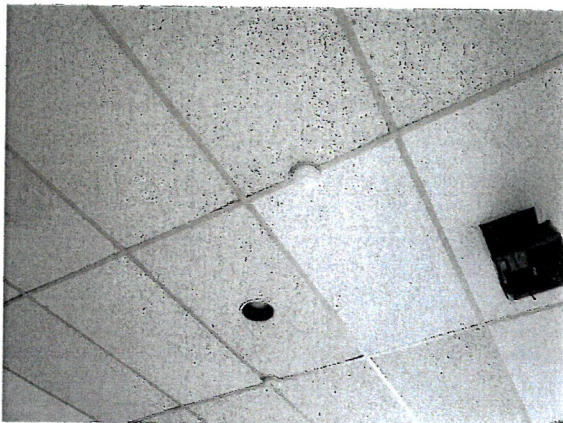
Smoke detectors were observed (see photos). Smoke detectors often contain the radioactive material americium. These must be handled and disposed of in accordance with Canadian Nuclear Safety Commission (CNSC) regulations.

Smoke Detector (Americium)
