Firehall Feasibility Study

Cowichan Bay Improvement District &
Cowichan Bay Volunteer Fire Department

cowichan bay volunteer firehall **feasibility study**

issued: 2018- december - 3

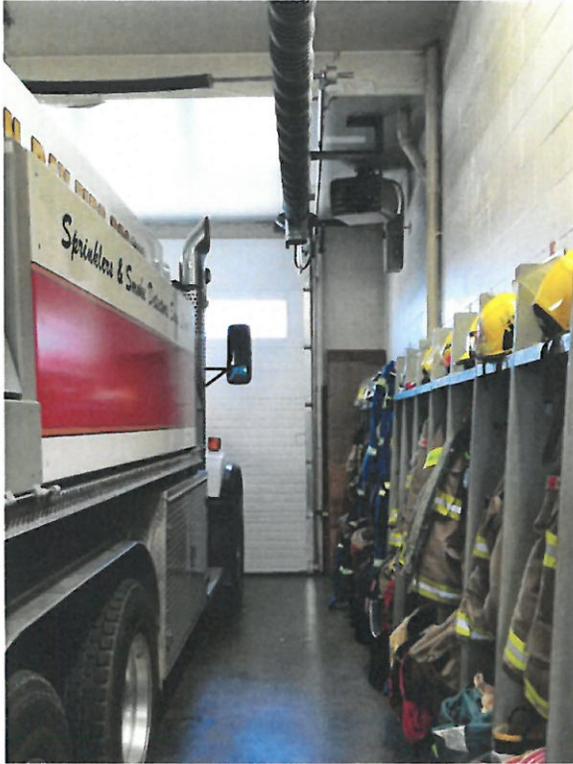
PPE area located within the apparatus bays instead of separate room. Limits movement around vehicles.

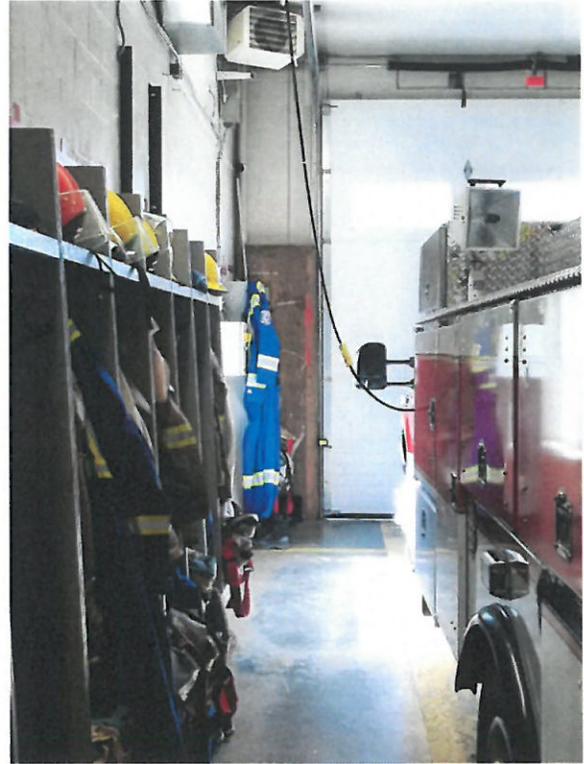
PPE equipment exposed to vehicle exhaust and contaminants. Exposed to apparatus bays is no longer industry standard.

- PPE is exposed to vehicle exhaust, grease, oil, fuel and other similar pollutants.
 - Cleaned and ready-to-wear PPE Gear which is stored in the apparatus bays are exposed to contaminants from other dirty gear + equipment. Storing this equipment in a separate room meets today's industry standards.

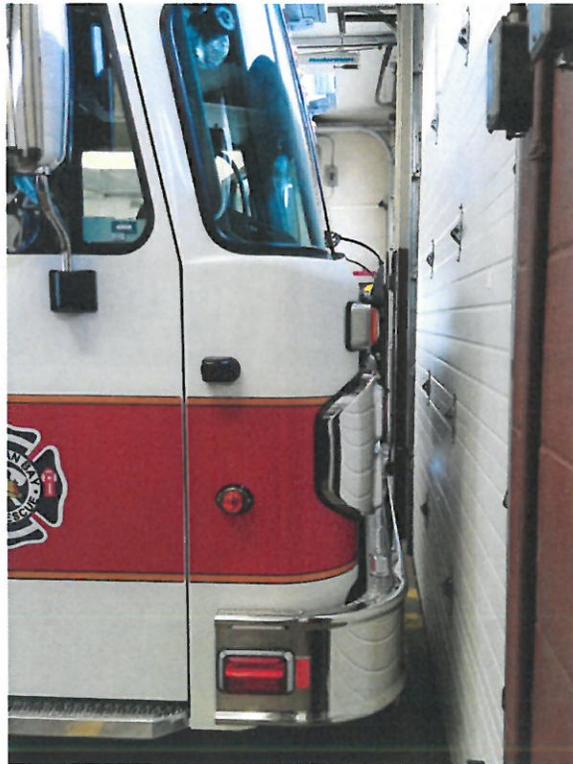
Size of the apparatus bays limits available movement around the vehicles which restricts response time and safety of crews.

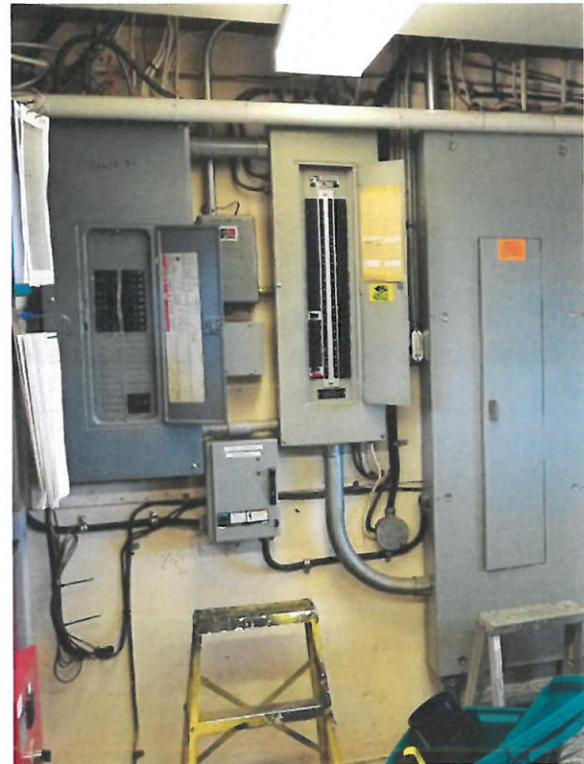
Electrical systems and wiring - located directly off the bays.

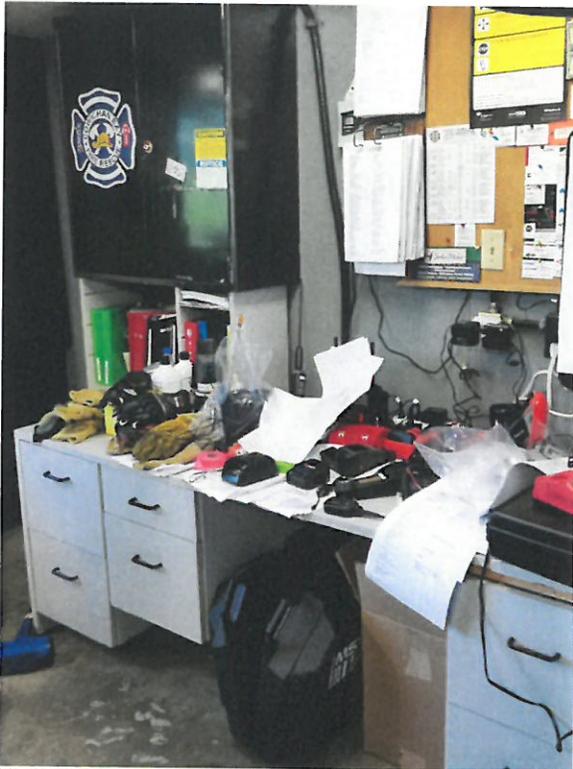
Workshop area is combined with work station and SCBA. Limited workspace and storage.

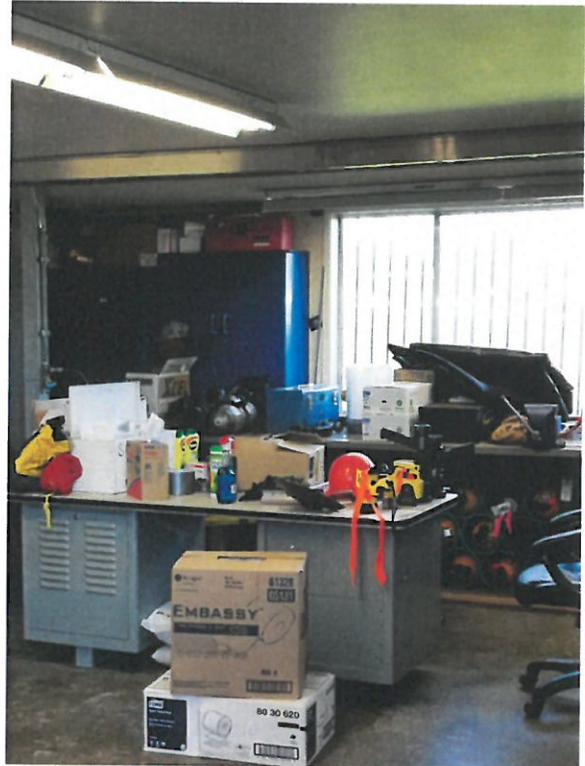
Workshop area / SCBA Room: Limited workspace and storage which is open to the bays

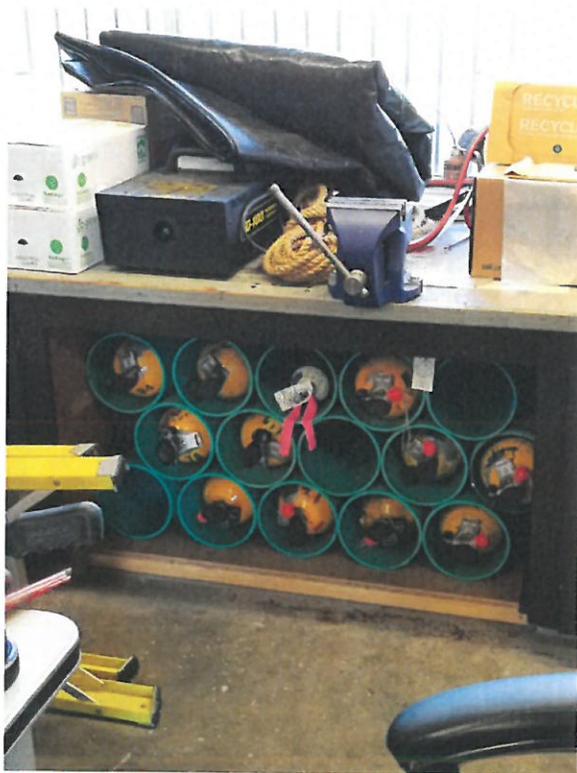
SCBA equipment, general storage and workshop all stored in one area with no separation between clean and dirty.

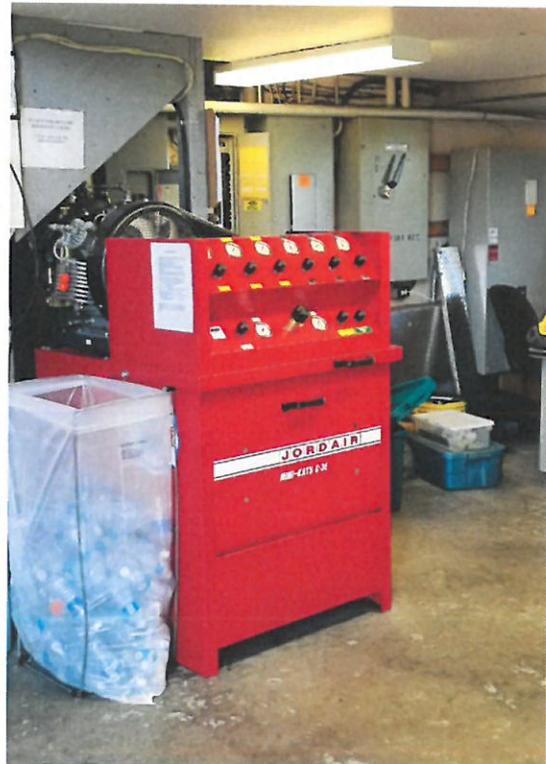
SCBA fill station and compressor located directly off the apparatus bays

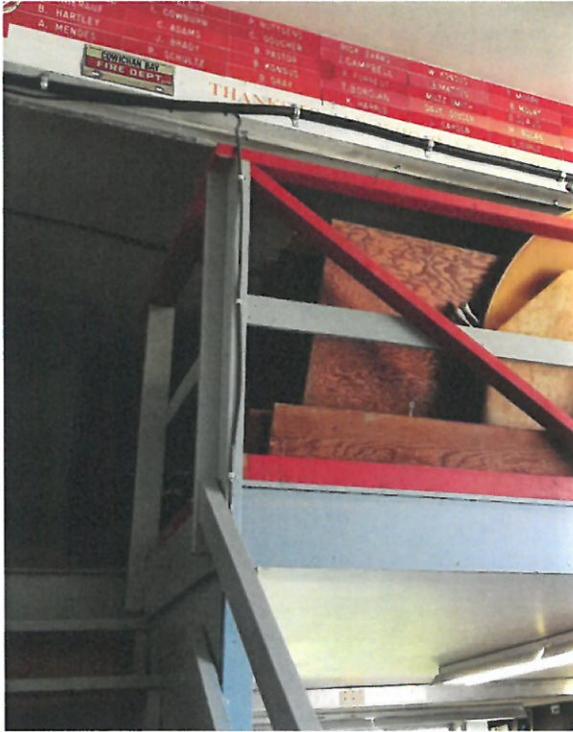
Makeshift storage located above workshop area.

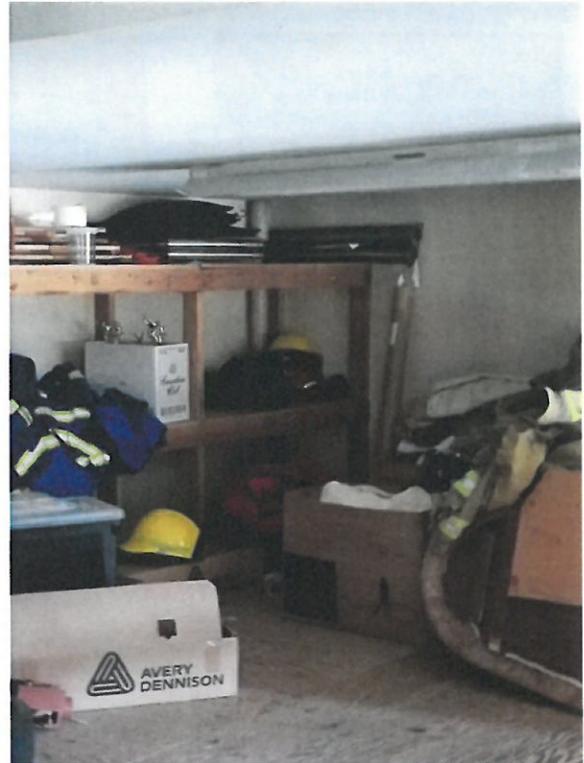
Low-quality lighting in makeshift storage areas. Storage areas make good use of odd spaces.

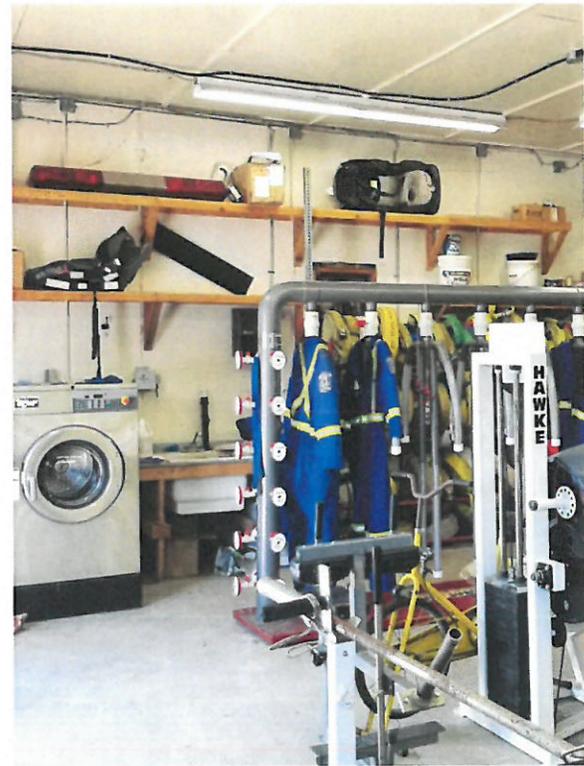
Gear washing and health and wellness in same area - out in the storage building away from the main firehall

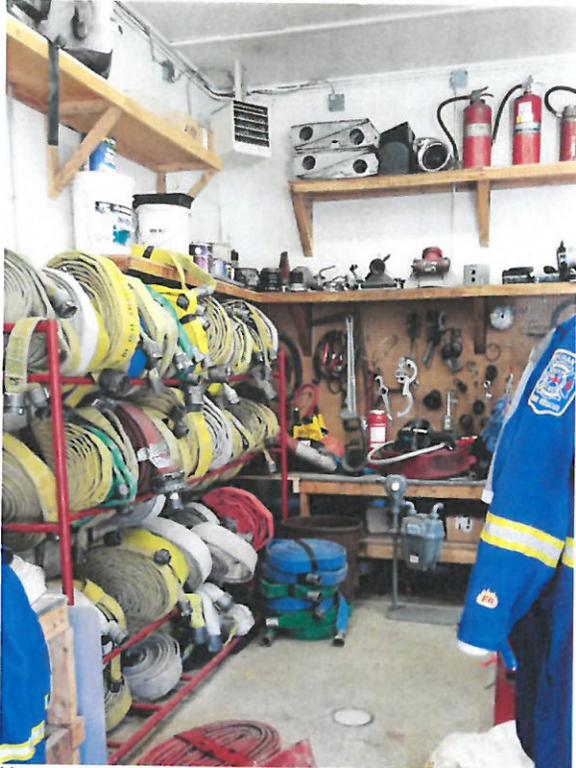
Hose storage and additional general workshop area located outside the hall in the storage building.

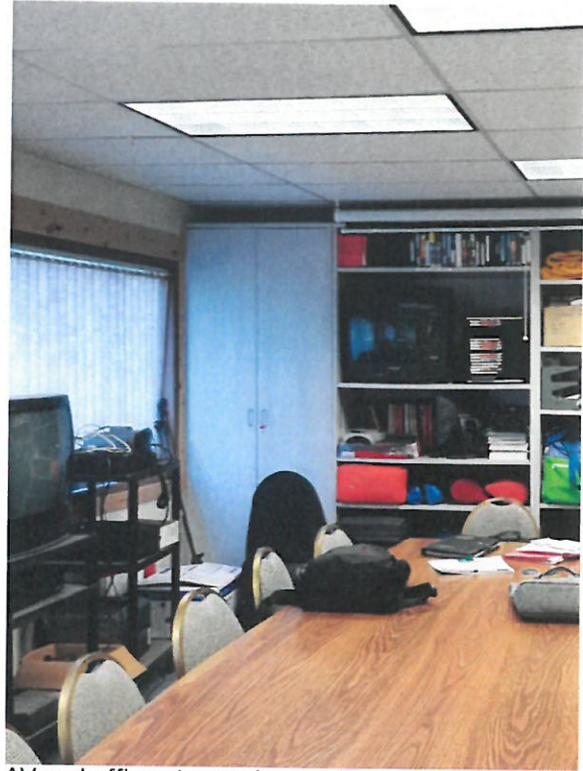
AV and office storage in meeting space.

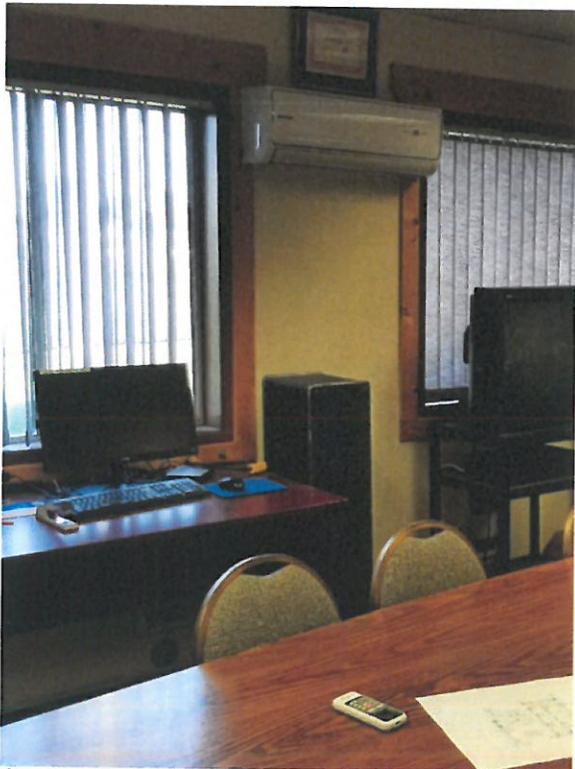
Crowded use of meeting space - office spaces are located in meeting room.

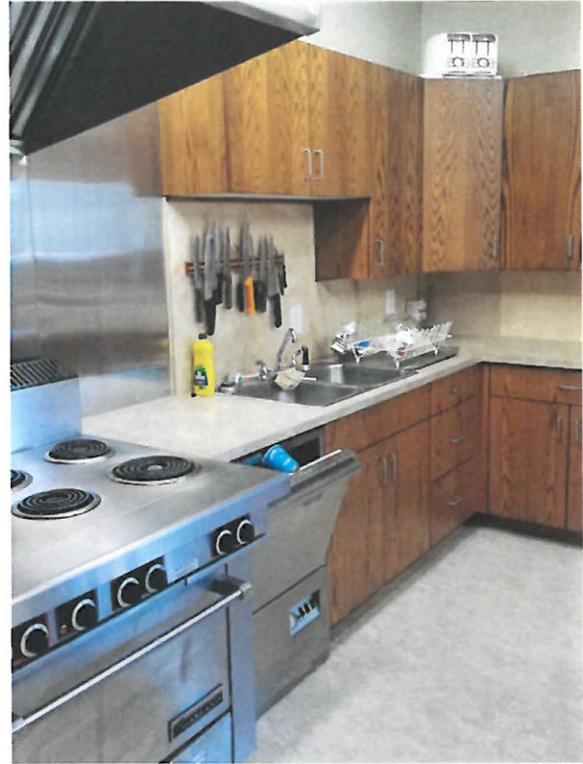
Great size kitchen with good equipment. Millwork could use an update with countertops redone for longevity.

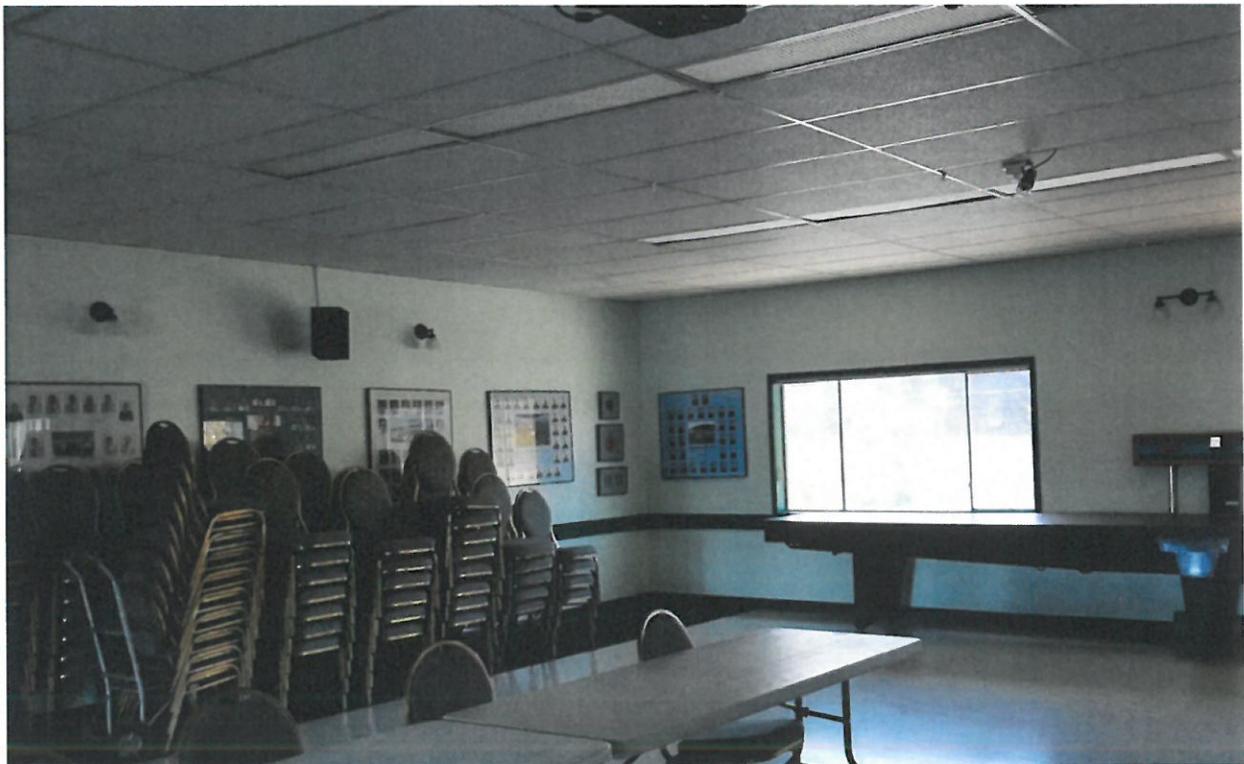
Training Room, Chair Storage + Day Room Area in shared space.
