Firehall Feasibility Study

Cowichan Bay Improvement District &
Cowichan Bay Volunteer Fire Department

cowichan bay volunteer firehall **feasibility study**

issued: 2018- december - 3

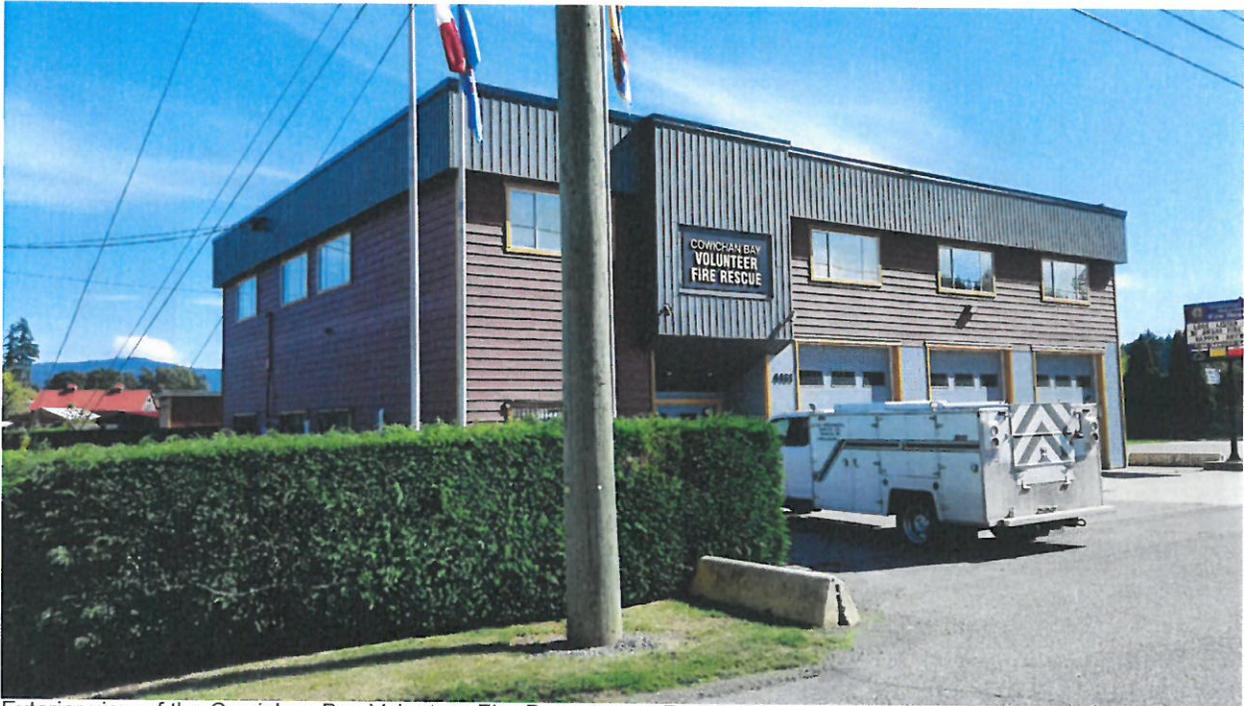
Exterior view of the Cowichan Bay Volunteer Fire Department: Front and southern facade looking north east.

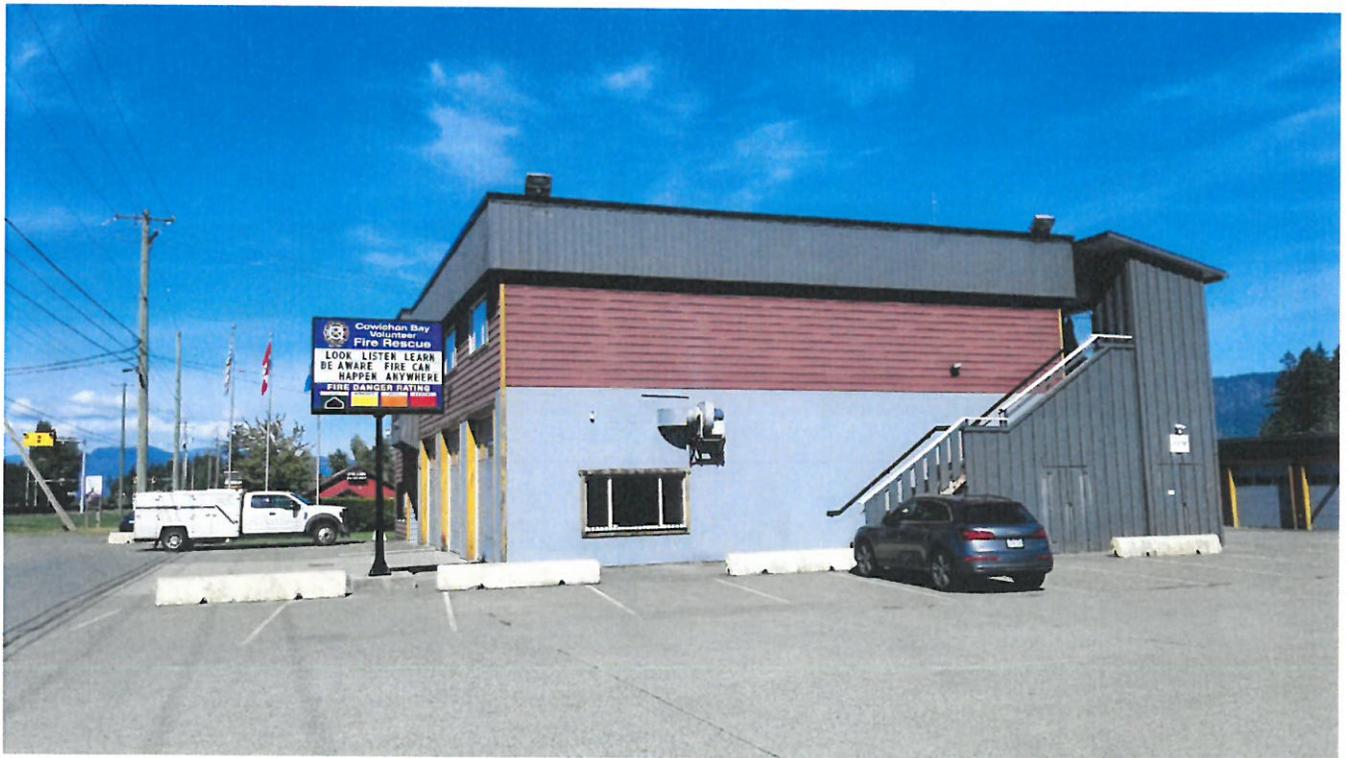
Exterior view of the Cowichan Bay Volunteer Fire Department - eastern facade looking west from the eastern parking area.

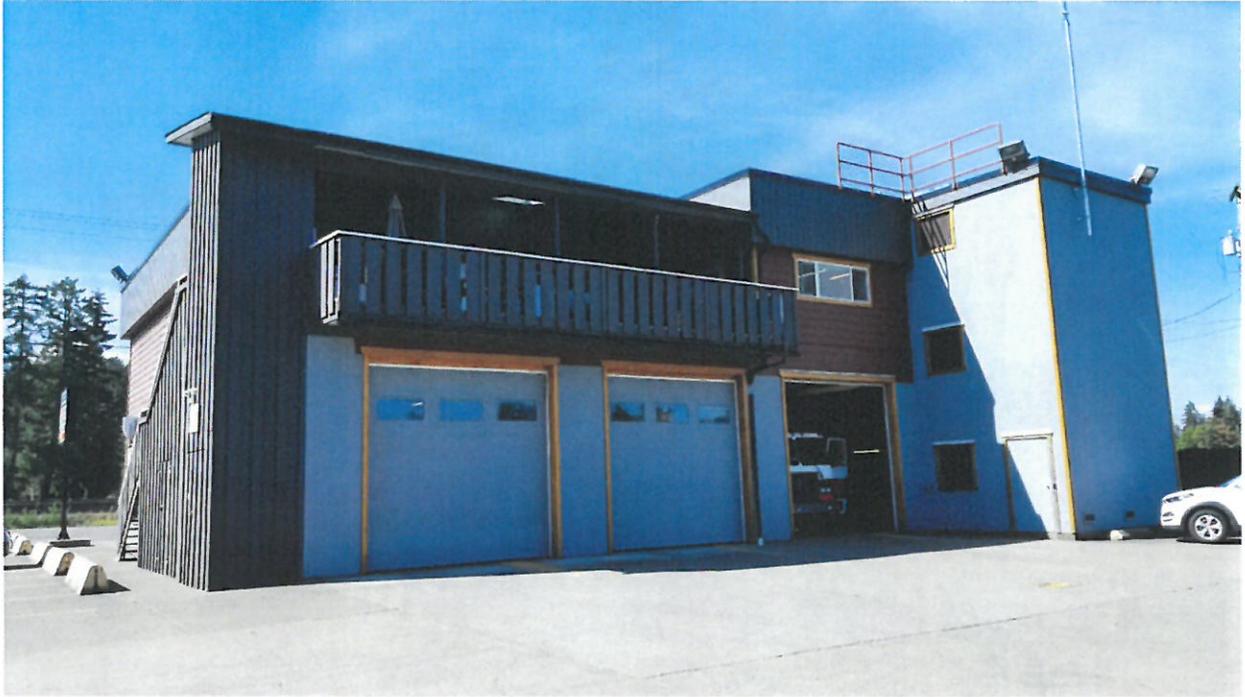
Exterior view of the Cowichan Bay Volunteer Fire Department - North facade looking south-west from parking area between storage building.

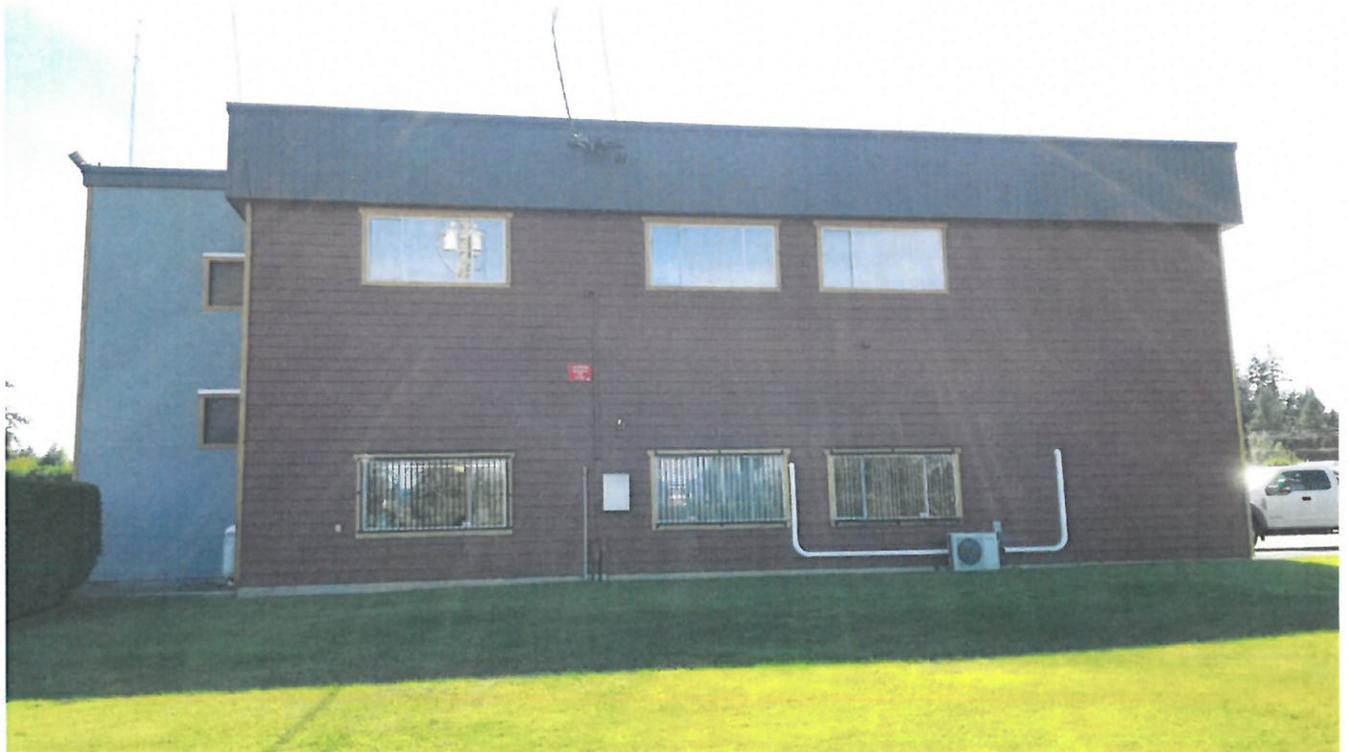
Exterior view of the Cowichan Bay Volunteer Fire Department - western facade looking west from the eastern parking area.

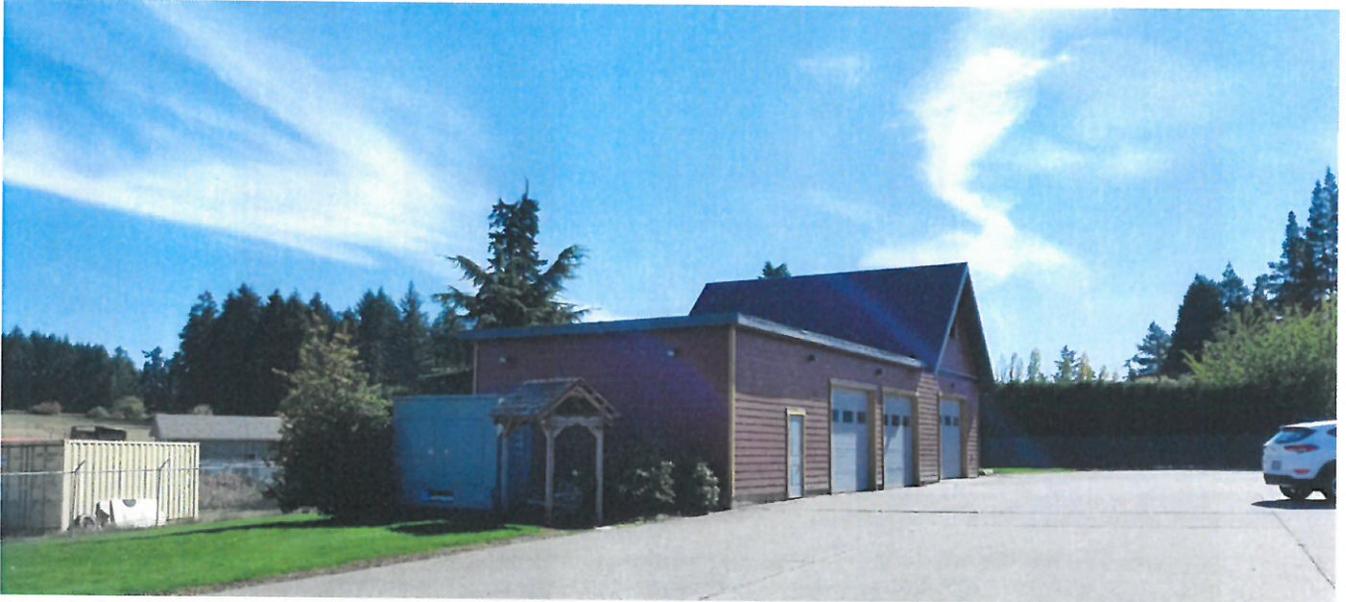
Exterior view of the Cowichan Bay Volunteer Fire Department - looking east from the western site entrance towards the storage building

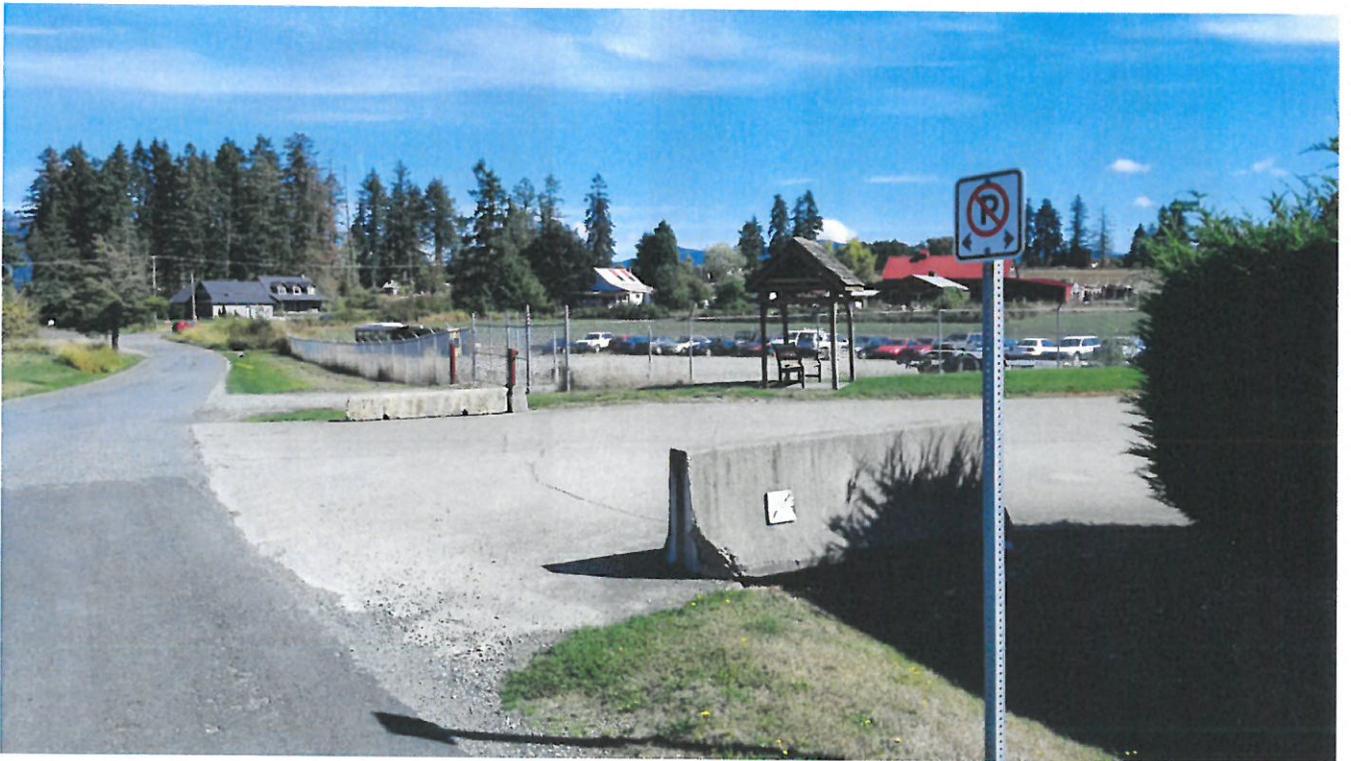
Exterior view of the Cowichan Bay Volunteer Fire Department - looking north from the western site entrance towards the training yard and down Wilmot Road

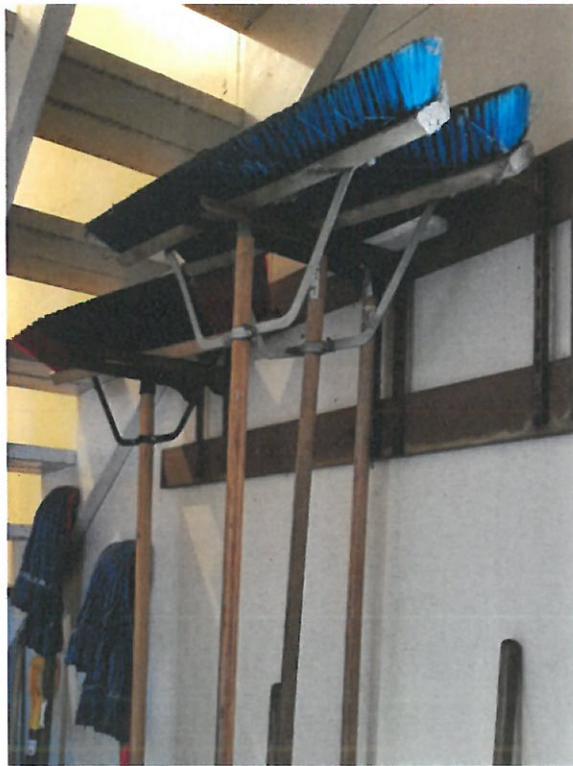
Cleaning equipment in hose tower.

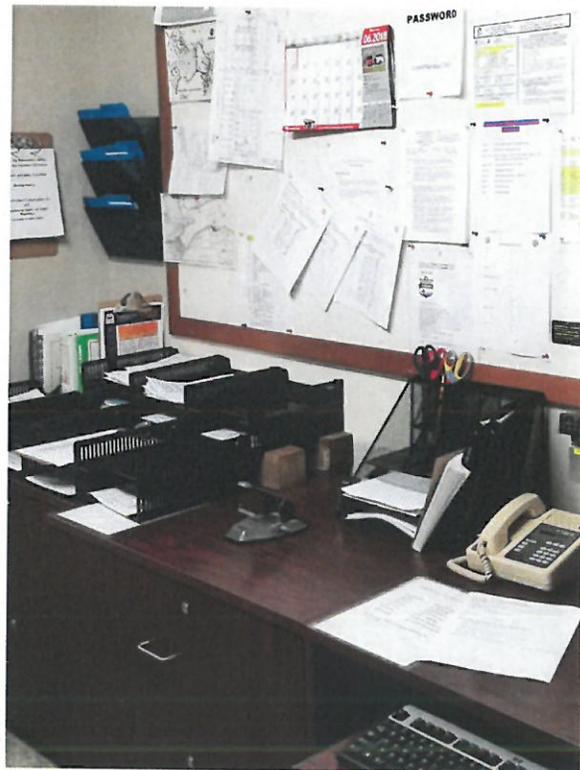
Desk Area + Radio Room

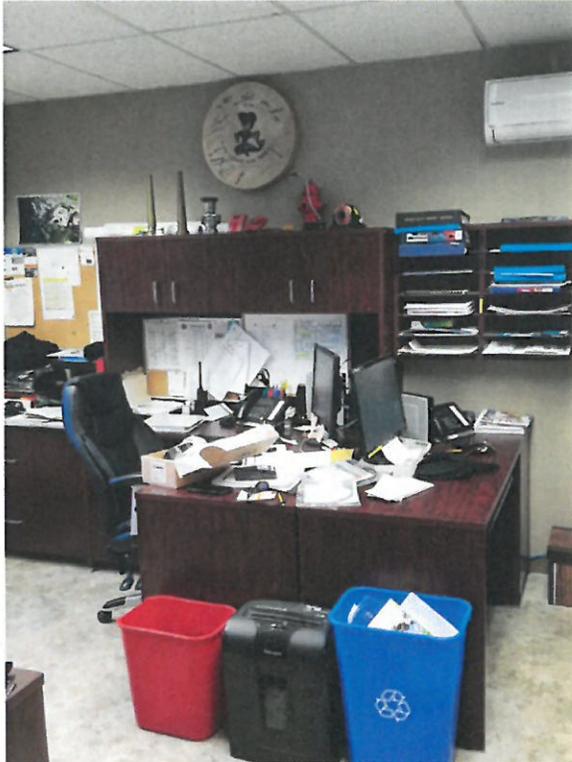
Shared office space for Chief, Deputy Chief and Training Officer.
